CON-AID in Uganda

Kaserem-Sipi-Kapchorwa Road:

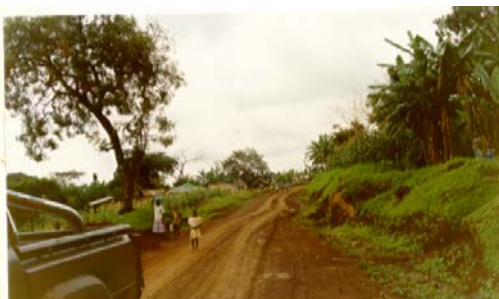
Before CON-AID Application on Kaserem-Kapchorwa Road (beginning of escapment before Sipi Trading Center)
 Five years after CON-AID application Kaserem-Kapchorwa road (beginning of escapment before Sipi Trading Centre)
 The Ministry of Works Transport and Communications carried

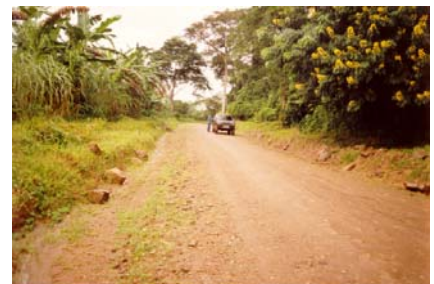
The M.O.W.T&C carried out Quality Control and monitoring at a site laboratory in Bundibugyo town. Ntandi - Bundibugyo Road 4 months after CON-AID Application.

The observations and findings made are similar to those of Kaserem - Kapchorwa road. Generally, the road has improved tremendously after the application of CON-AID. After construction, the road experienced heavy-armed vehicles and heavily loaded World Food Program Vehicles. Although this was during the heavy El-Nino rains, the road performed very well.
